Exhibit 40

Job No. 070810
August 14, 2007

Subject: Geotechnical Inspection of Residence
5725 Soledad Mountain Road
La Jolla, CA 92037

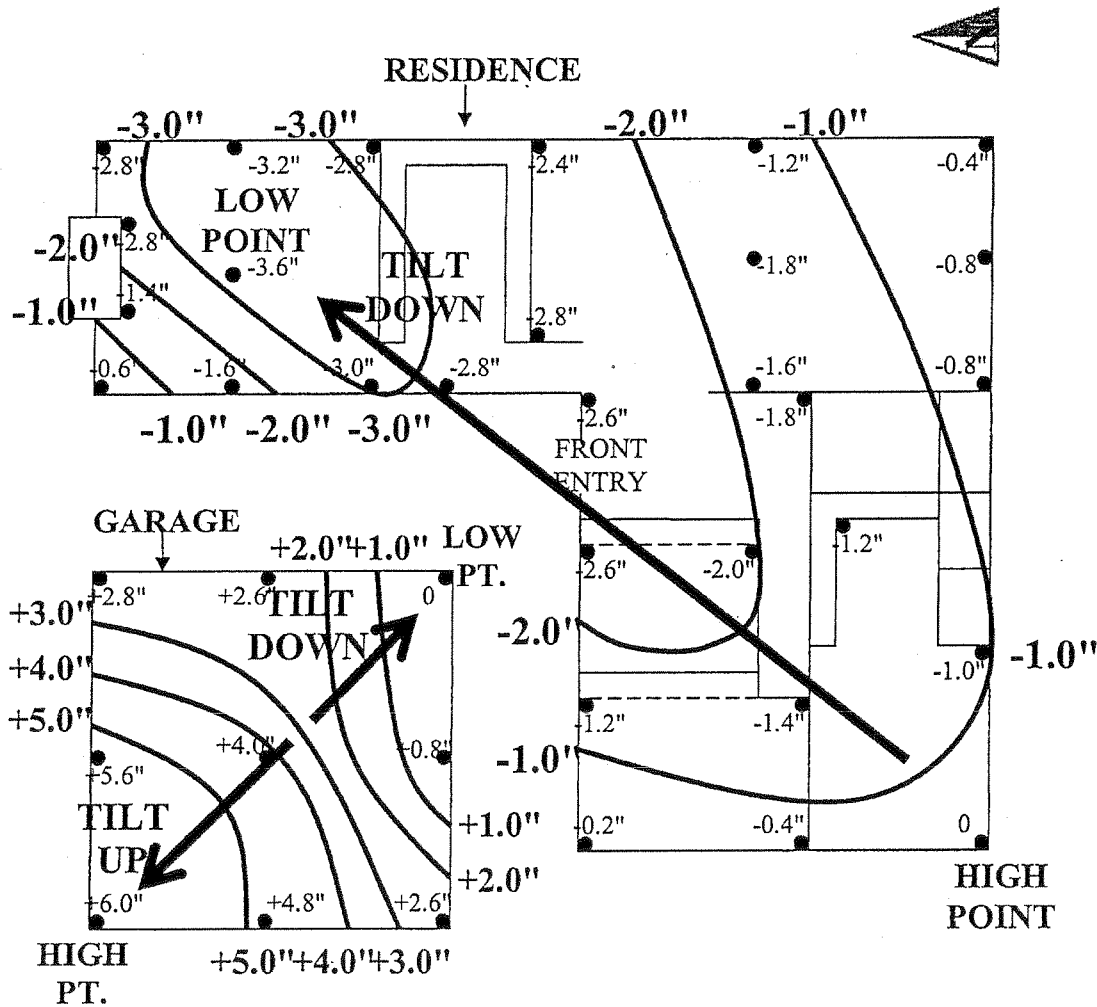
**FIGURE 1
FLOOR LEVEL SURVEY**

The results of the survey are shown on the attached Figure 1 and reveal that the living area floor slab has a maximum elevation difference of 3.6 inches. The high point is located at the southwest corner of the house, in the main bedroom. The low point is located near the northeast corner of the residence, in the family room. The overall floor tilt is down to the northeast.

The garage floor slab has an elevation difference of 6.0 inches. The high point is located at the northwest corner of the garage. The low point is located at the southeast corner. The upward slope of the garage slab (towards the garage door) is unusual since garage slabs are normally poured with a downward slope, for drainage purposes.

The living area and garage floor elevation differences are both indicative of soils movement. Normal floor level construction tolerance is about 1 inch.

1. Two types of soils movement appear to have occurred beneath the residence and garage. The living area portion of the residence appears to have experienced downwards soils movement, most likely due to differential settlement of underlying fill soils. The amount and direction of settlement is equivalent to the floor elevation difference shown on the attached Figure 1, Floor Level Survey. The magnitude of differential settlement (3.6 inches) is in the moderate range. However, the associated building damage is relatively minor.

2. The garage appears to have undergone both downwards and upwards soils movement. At the southeast corner, the garage slab has settled approximately 3 inches, along with the rest of this portion of the residence. At the northwest corner, the garage slab has heaved approximately 3 inches, apparently due to soils expansion. The garage slab uplift is in addition to the garage foundation uplift in this area. (Please note, tree root spreading was also considered as a possible source of uplift, but there are no large trees near the northwest corner of the garage.)

1. Because of the large amount of vertical soils/foundation movement (6 inches or more), deep foundation repairs to the residence and garage may be necessary. However, prior to formulating foundation repairs, the residence should be monitored for an additional period of at least 6 months (February 2008) to allow further observation of the residence and garage/driveway. At the end of this period, an additional building inspection should be made. A subsurface soils investigation will also be necessary prior to formulating foundation repairs.
